# **5 VOLT FlashFile™ MEMORY**

## **28F004S5, 28F008S5, 28F016S5 (x8)**

### **SPECIFICATION UPDATE**

Order Number: 297796-007

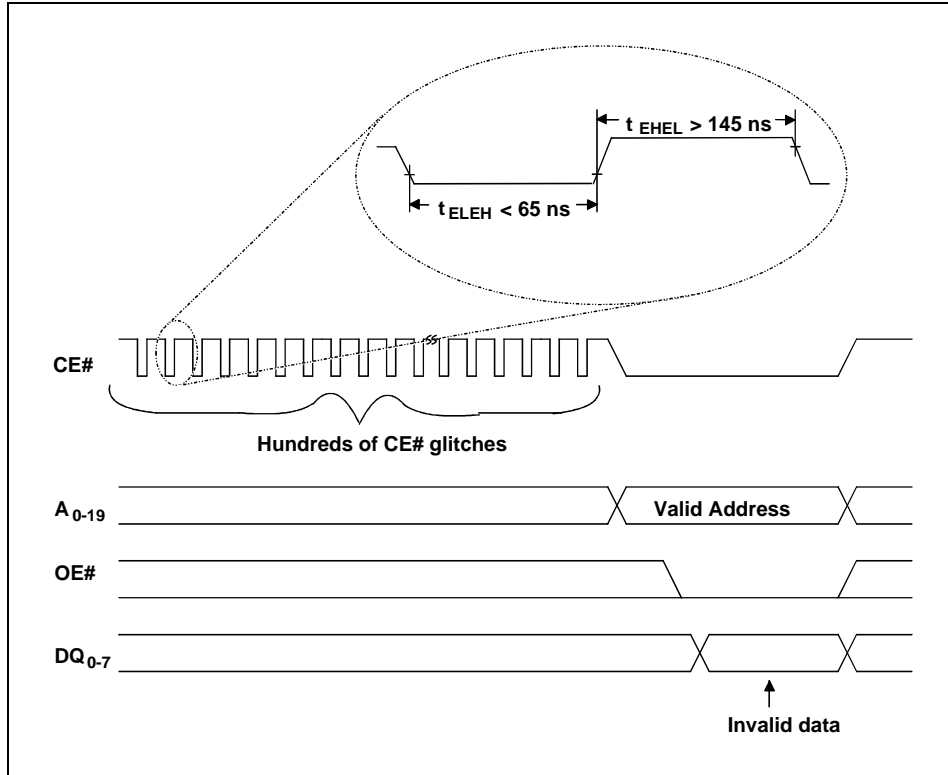
**A Long Series of CE# Glitches May Induce an Invalid Read**

**PROBLEM:** A noisy CE# control signal may cause an invalid read. This erroneous read only occurs after the device has received over one hundred consecutive short CE# glitches ( $t_{EHL} < 65 \text{ ns}$ ) with CE#-high time ( $t_{EHL}$ ) greater than 145 ns (see the figure below, *A Long Series of CE# Glitches May Induce an Invalid Read*).

After valid data is read, the device must receive another series of CE# glitches (typically over one hundred) to induce an invalid read.

**IMPLICATION:** This erratum may affect read operations in systems that have a lot of noise on the flash memory's CE# input. If CE# is generated asynchronously from the upper address lines, noise on CE# can sometimes occur when upper address lines transition from one state to another. However, applications that access flash memory sequentially will have stable upper address lines and will therefore produce fewer CE# glitches. Systems that execute code from flash memory or download code from flash memory into DRAM will usually access the device sequentially; therefore, they will be less susceptible to this erratum.

1. In systems that flow unlatched addresses to CE# control logic, the decode logic may generate CE# glitches when the address bus transitions from one state to another. However, the processor's address switching frequency is usually very fast (somewhere in the order of 1/2 the processor's operating frequency) which will cause the glitch high time to be less than 145 ns. If the CE#-high time is less than 145 ns, the glitch has no effect on the component.

2. If the address bus is not pulled up or pulled down during idle bus cycles, the address bus may be left in an undetermined state. This condition may cause CE# glitches.

Add system logic to prevent CE# glitches such as latched CE# control logic or pullup/pulldown resistors to the address bus.

If the device receives over one hundred consecutive CE# glitches, issue a Byte Write command and program FFh to any location before executing a read operation. Programming FFh will not alter stored data, but it will give the component sufficient time to prepare for the read operation.

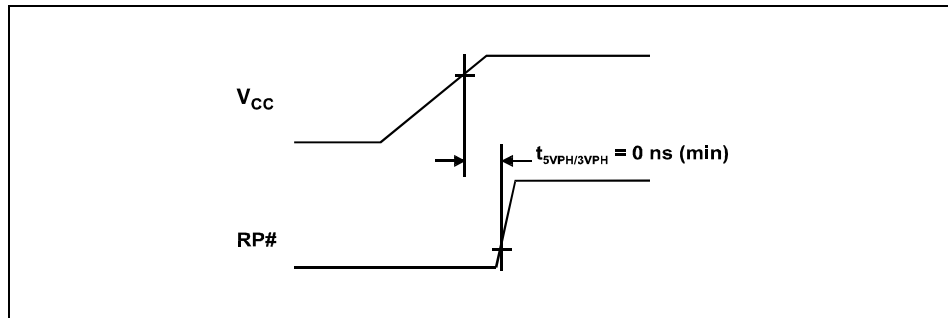
**Hold RP# Active While  $V_{CC}$  Ramps**

**PROBLEM:** RP# must be held low while  $V_{CC}$  ramps to a valid level during power transitions.

Holding RP# low during power-up blocks spurious writes initiated by system control logic which may occur as the system voltage transitions to a stable level. Intel recommends the use of RP# for CPU/memory reset synchronization, write protection, and deep power-down mode.

**IMPLICATION:** This erratum only affects power-up operations. Systems that tie the flash memory's RP# input to the system RESET# signal typically will not have a problem with erratum because the RESET# signal is usually held low during the power-up sequence to properly synchronize the CPU. However, systems that tie RP# directly to  $V_{CC}$  will be more exposed to this problem. So, carefully analyze RP# during the power-up condition to fully understand its behavior.

Use a simple RC delay network to hold RP# low during the power-up condition or tie the RP# input to the system RESET# signal. This workaround will eliminate your exposure to this problem and also provide your design with addition power-up security.
