PIC32MZ EF FAMILY

PIC32MZ Embedded Connectivity with Floating Point Unit (EF) Family Silicon Errata and Data Sheet Clarification

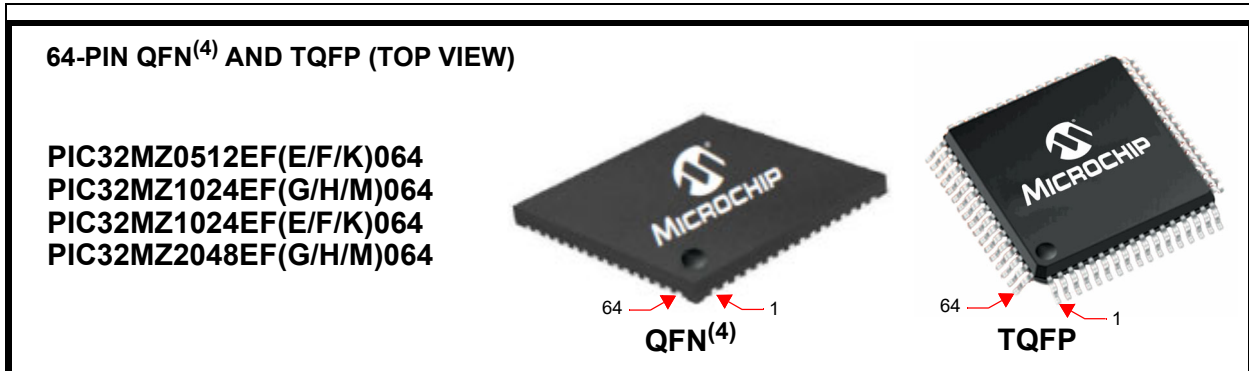
In Table 2. “Pin Names for 64-pin QFN and TQFP Devices” of the current data sheet, the AECRS_{DV} signal was erroneously omitted from the pin number 44 and added to the pin number 62. The correct assignment is shown in bold type in the following table.
