3 Volt Intel[®] Advanced+ Boot Block Flash Memory

28F800C3, 28F160C3, 28F320C3, 28F640C3

Specification Update

November 2002

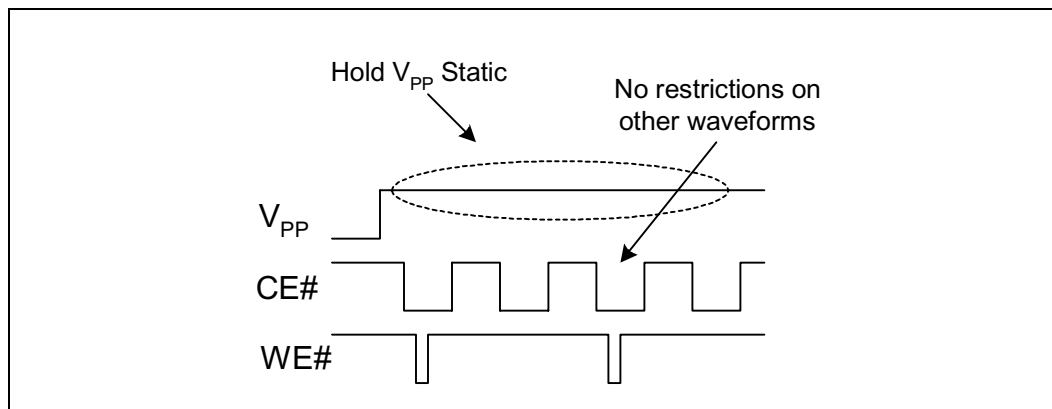
Problem: The 0.18 μ m 28F320C3xC devices can unintentionally reset under certain conditions where V_{pp} toggles.

Implication: When the reset occurs, any command being executed is interrupted and the flash switches to read array mode.

- 1) Tie V_{pp} to V_{CC} ;
- 2) If the third and fourth digits on the top side FPO mark (third line) is equal or greater than “23”, then V_{CC} may be set from 2.7v to 3.3v. V_{CC} must not exceed 3.3v
- 3) Set V_{pp} to a static high or static low level as shown here; and

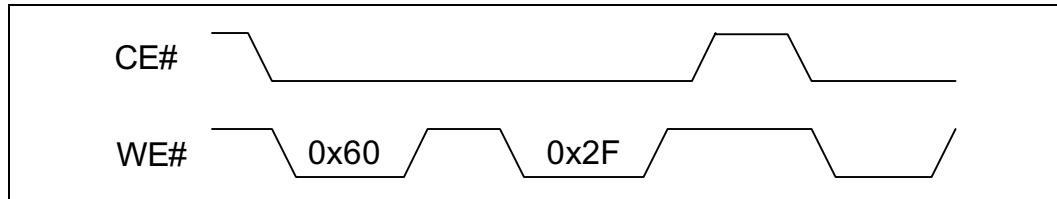
Problem: On the 16Mb and 64Mb 0.18µm devices, if CE# is deasserted after any block lock operation and before the next write sequence, the part may perform the same operation on additional blocks. (See waveform below.)

Implication: When CE# is deasserted after performing a block lock operation to a specific block and prior to the next write sequence, other blocks may perform the same operation.
