## PIC24FJ256GB110 Family Silicon Errata and Data Sheet Clarification

The PIC24FJ256GB110 family devices that you have received conform functionally to the current Device Data Sheet (DS39897C), except for the anomalies described in this document.

**Note:** This document summarizes all silicon errata issues from all revisions of silicon, previous as well as current. Only the issues indicated in the last column of [Table 2](#) apply to the current silicon revision (**A6**).

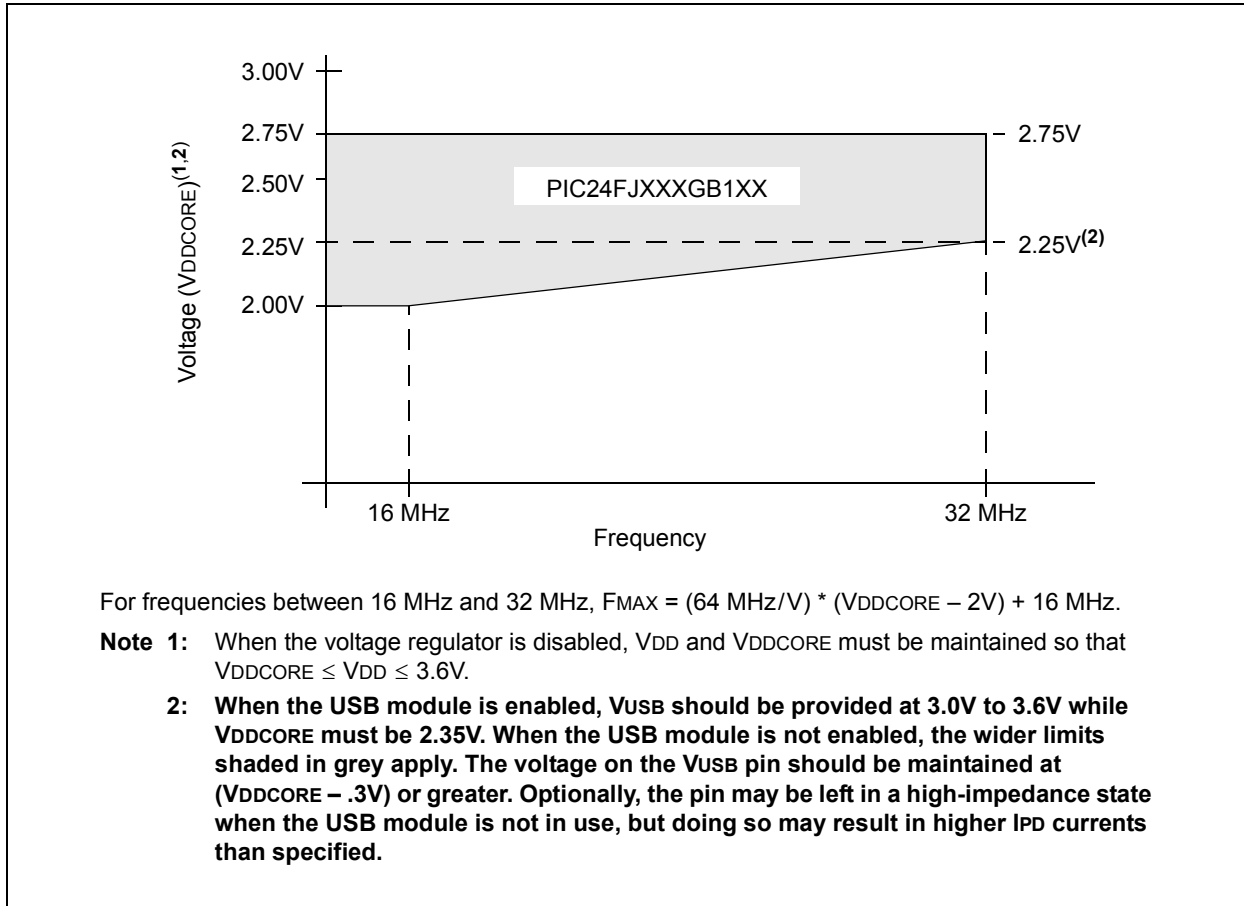
**FIGURE 29-1: PIC24FJ256GB110 FAMILY VOLTAGE-FREQUENCY GRAPH (INDUSTRIAL)**

Figure 29-1 (“PIC24FJ256GB110 Family Voltage-Frequency Graph”) is amended by adding an additional footnote. The updated figure is shown below (changes in **bold**; bold in original removed for clarity).
