**THE DATASHEET OF  
RC28F320J3A110**

# **3 Volt Intel StrataFlash<sup>®</sup> Memory**

## **28F128J3A, 28F640J3A, 28F320J3A**

### **Specification Update**

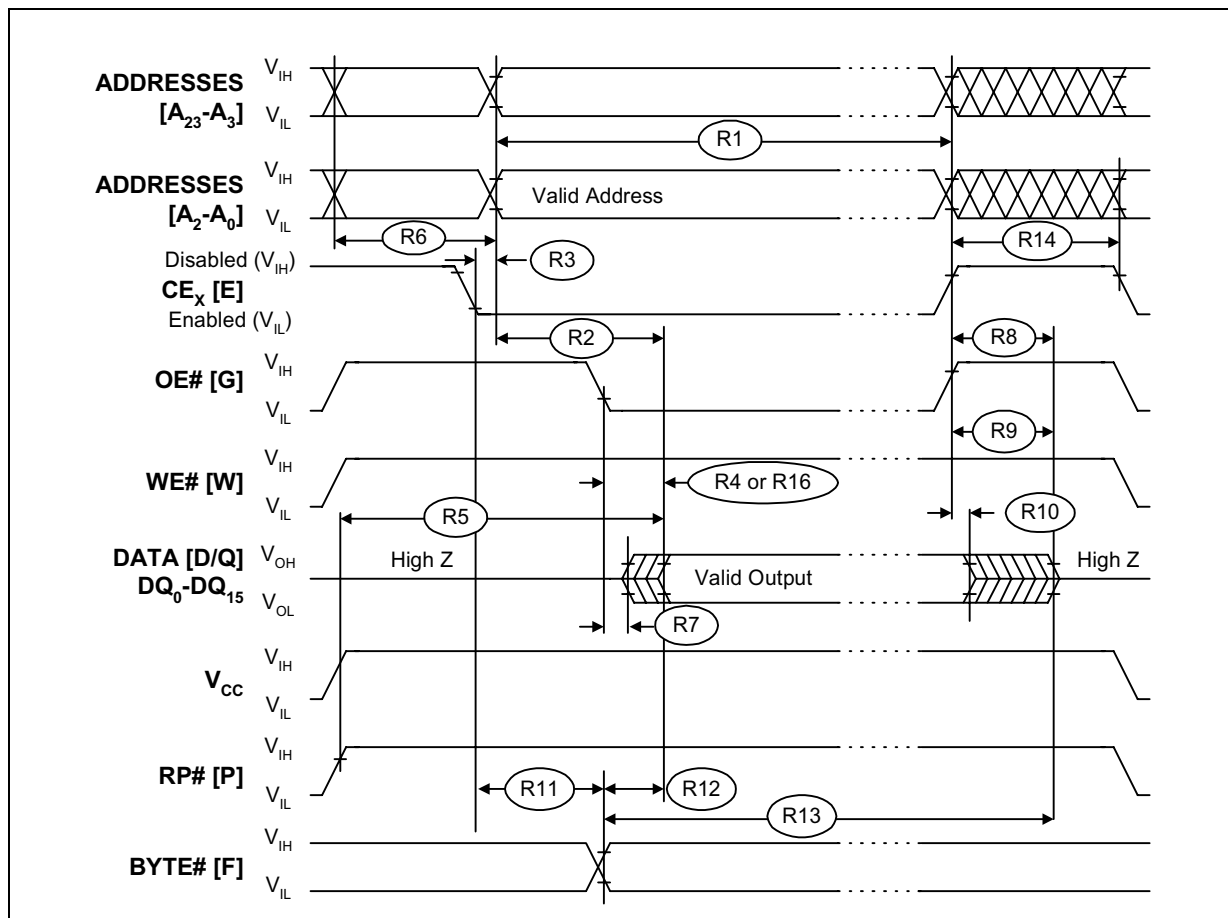
Figure 1. AC Waveform for Standard Word/Byte Read Operations

Problem: Devices need the parameter  $t_{ELQX} = 150$  ns minimum. CE low to output in low Z ( $t_{ELQX}$ ) is designated as R6 in Figure 1, in this Specification Update revision.

Problem: Devices need the parameter  $t_{ELAV} = 500$  ns maximum. Chip Enable to Address Valid ( $t_{ELAV}$ ) is designated as R3 in Figure 1, in this Specification Update revision.

Problem: The parameter  $t_{ELQV}$  has been deleted.

Workaround: Use devices for initial lower volume prototype development.
