# THE DATASHEET OF STM32L051C8T6

This errata sheet applies to the revision A, Z, Y and X of STMicroelectronics STM32L051x6/8 microcontrollers.

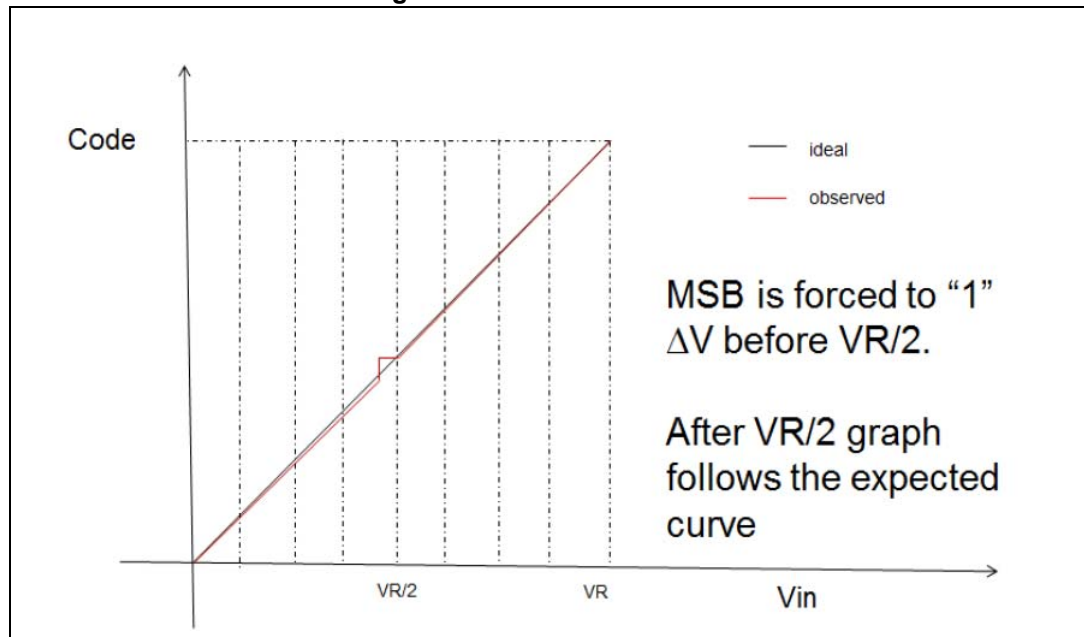
Figure 1. Data transfer curve

When  $V_{REF+}$  is lower than  $V_{DDA}$ , and only in this case, the data MSB is forced to '1' just before  $V_{IN}$  reaches  $V_{REF+}/2$ . As a result, the data transfer curve shows a discrepancy around  $V_{REF+}/2$  (see [Figure 1](#)).

Note: The transfer curve behaves as expected when  $V_{IN}$  is strictly lower or higher than  $V_{REF+}/2$ .
