# THE DATASHEET OF OMAP5912ZZG

**OMAP5912**  
**Applications Processor**  
**Silicon Errata**

SPRZ209K  
December 2003 – Revised December 2007

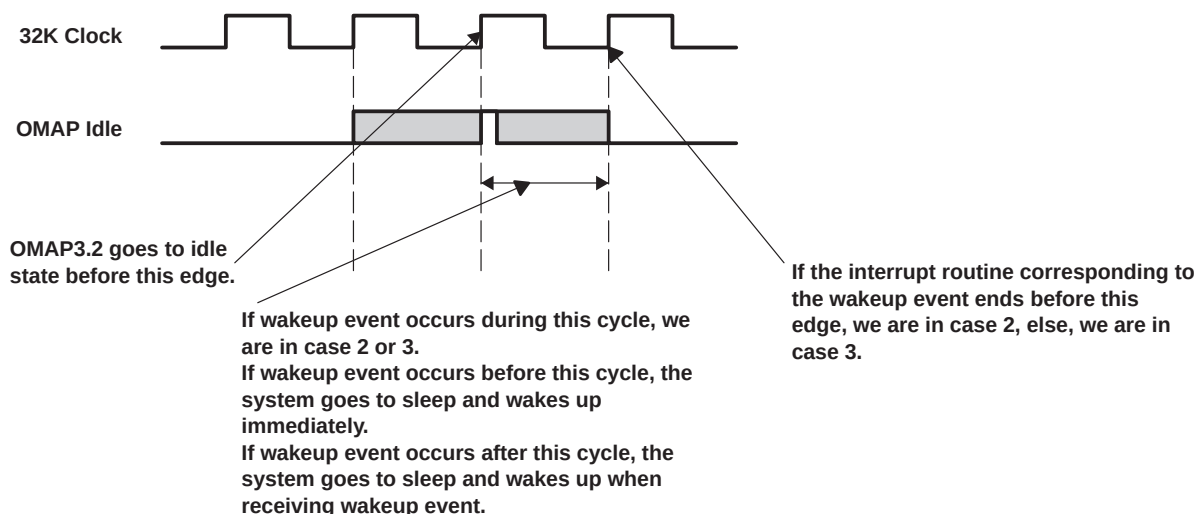
**Figure 14. IDLECT1.WKUP\_MODE = 1 Possible Effects**

1. No noticeable problem. The system wakes up correctly.
2. The OMAP3.2 clock is shut down while the ARM is awake (possibly in the middle of an instruction fetch). The wakeup event is caught, and corresponding interrupt routine has time to complete before the ARM clock is shut down. The system will go to sleep and resume normal operation on the next wakeup event (first wakeup event will be treated at this time). Depending on the time when OMAP3.2 clock was shut down, instruction/data corruption is possible.
3. The OMAP3.2 clock is shut down while the ARM is awake (possibly in the middle of an instruction fetch). The wakeup event is caught, but corresponding interrupt routine does not have time to complete before ARM clock is shut down. The system will resume normal operation. Depending on the time when OMAP3.2 clock was shut down, instruction/data corruption is possible.

Figure 14 summarizes briefly the conditions under which case 1, 2, and 3 may happen.

**Workaround:** The IDLECT1.WKUP\_MODE bit should always be 0 in all OMAP5912 devices.

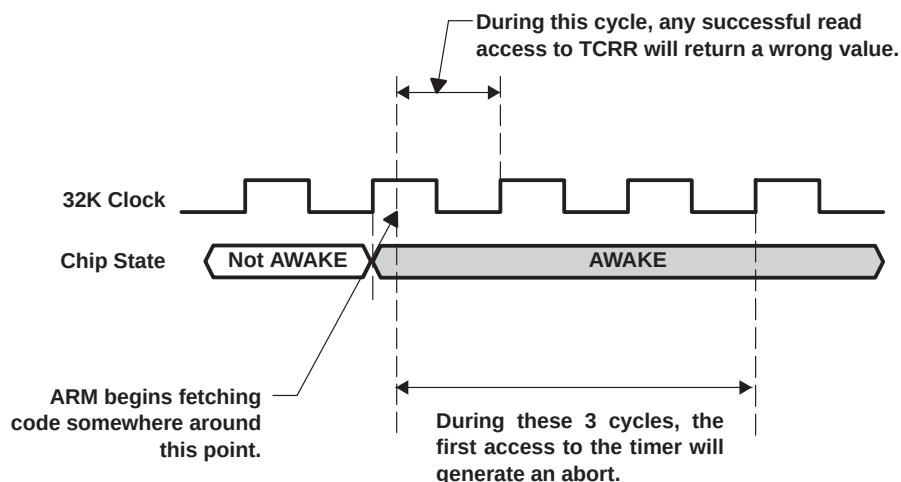
If the dual-mode timer functional clock is configured to be a 32-kHz clock, then this time can be significantly longer than the time it takes for the MPU to do an access to the dual-mode timer. In which case, if one of the first operations software performs after wakeup is an access to dual-mode timer, then the access is very likely to fail.

**Figure 16. DM Timer Access Timings After Wake Up From Deep Sleep (Functional Clock is 32K Clock)****Workaround:**
