PIC16F88X Family Silicon Errata and Data Sheet Clarification

The PIC16F88X family devices that you have received conform functionally to the current Device Data Sheet (DS41291G), except for the anomalies described in this document.

The silicon issues discussed in the following pages are for silicon revisions with the Device and Revision IDs listed in [Table 1](#). The silicon issues are summarized in [Table 2](#), [Table 3](#) and [Table 4](#).

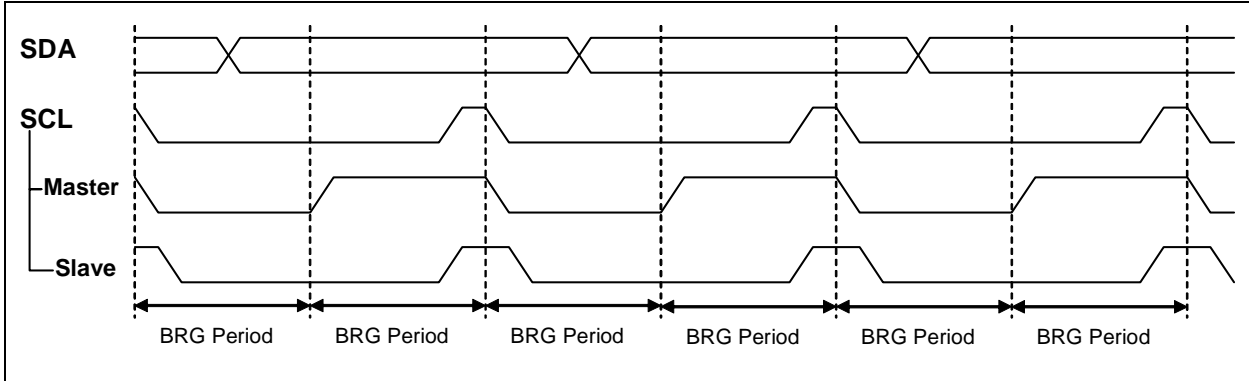
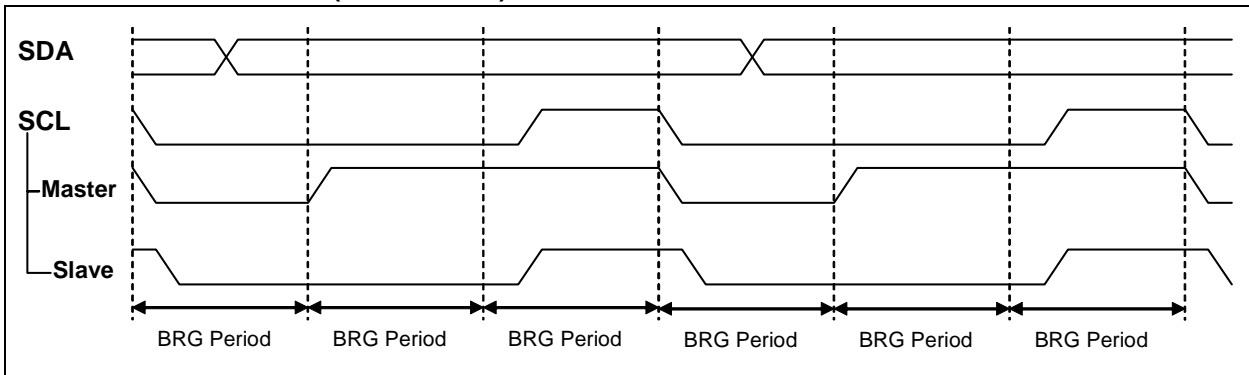
The current implementation does not ensure accurate SCL high time. During clock stretch, the MSSP device will erroneously continue running the BRG counter. At the end of the clock stretch, the BRG counter continues to count down for the

remainder of the BRG period, and then the MSSP device will immediately resume transmitting the data.

Figure 3 and Figure 4 illustrate an actual I²C transmission in which the slave has stretched the clock period by holding the SCL line low. Note that the high time of the SCL signal has shortened from the expected time.

Set the communication speed to match the slowest device on the bus. This ensures that no slave device will perform clock stretching.

It is possible to dynamically adjust the communication speed to match the device being addressed by modifying the BRG register. However, the behavior of slower slave devices must be understood and speed adjustments made such that no slave performs clock stretching.
