# **AM571x (SR 2.0, 1.0) and AM570x (SR 2.0) Sitara™ Processors**

## **Silicon Errata**

Literature Number: SPRZ436C  
October 2015–Revised February 2017

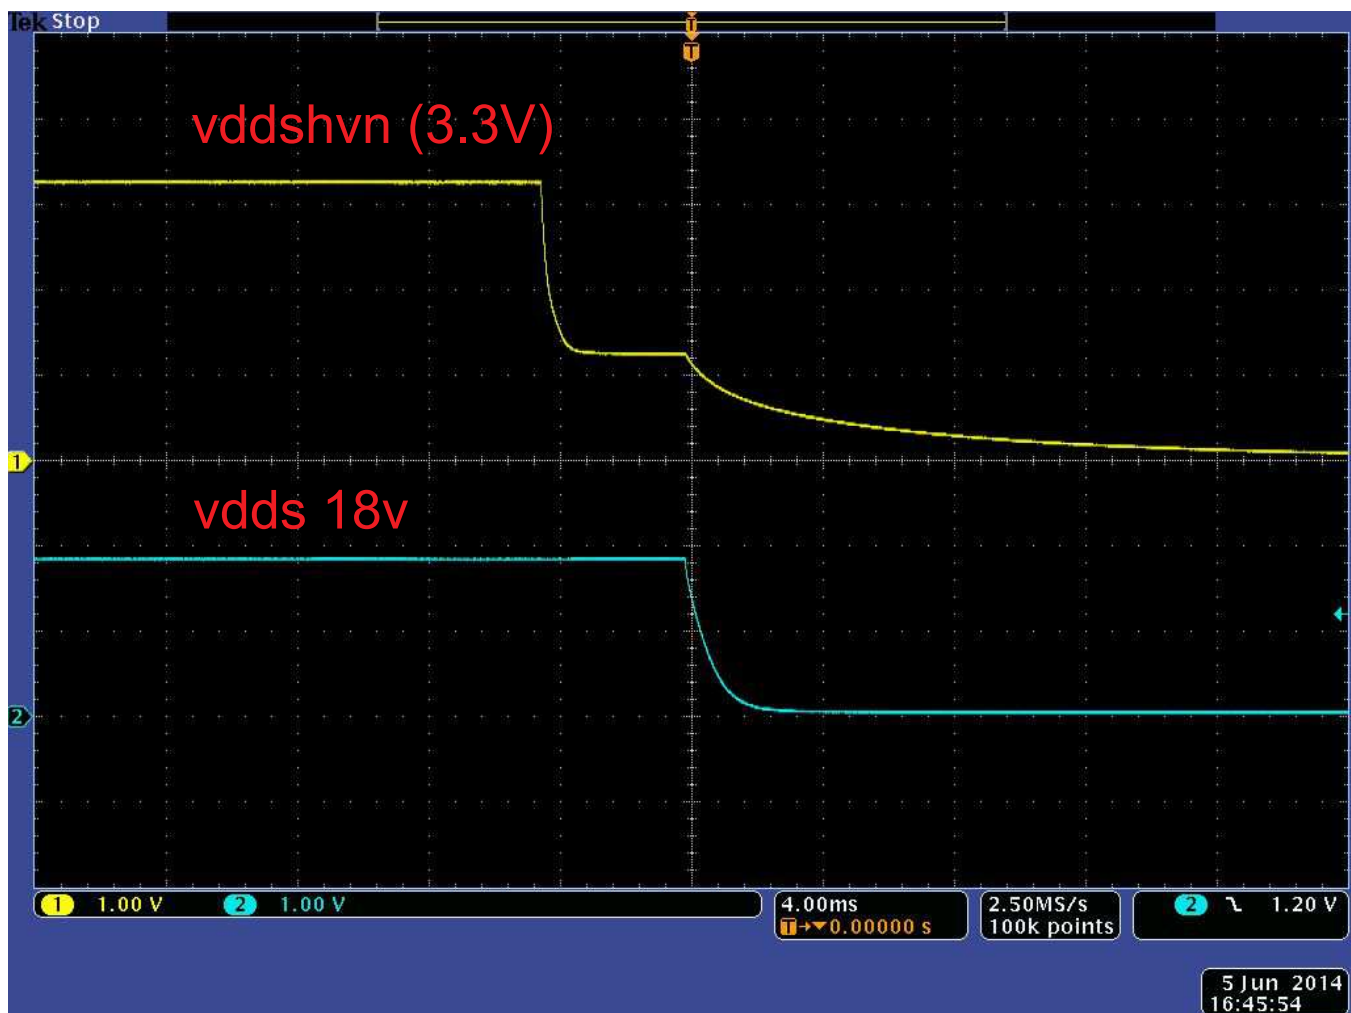
**Figure 4-1. PAB\_RevA**

A subset of the SOC's LVCMOS IOs (refer to DM for details) have a pull-up resistor that is active by default, including during reset and power-down. The SOC's IOs that have internal or external pull-ups will stay at Plateau Level (<1.5V) during the power-down. If other ICs on the board that are interfaced to the SOC's LVCMOS signals use a separate supply then it's possible that the other IC's signals can be pulled to the Plateau Level while its power supply is off.

The root cause of the plateau is related to the LVCMOS IO buffer Dual Voltage detection circuitry. The LVCMOS Dual Voltage IO includes voltage comparator circuitry to determine if the IO is in 3.3V mode or 1.8V mode. During powerdown of vddshvn domains, a current path in the internal bias transistors results in the vddshvn rail being held to an intermediate voltage level (<1.5 V). This path can consume at most 500 uA per IO - worst case estimate is ~150 mA (based on 280 IOs) from the vdds18v supply

during power down. This path is not a reliability concern for the device.

In general, TI recommends using the same supply source for connected components. E.g., a single LDO should drive vddshvn and the related 3.3V external components.
