PIC16(L)F1782/1783 Family Silicon Errata and Data Sheet Clarification

The PIC16(L)F1782/1783 family devices that you have received conform functionally to the current Device Data Sheet (DS41579D), except for the anomalies described in this document.

The silicon issues discussed in the following pages are for silicon revisions with the Device and Revision IDs listed in [Table 1](#). The silicon issues are summarized in [Table 2](#).

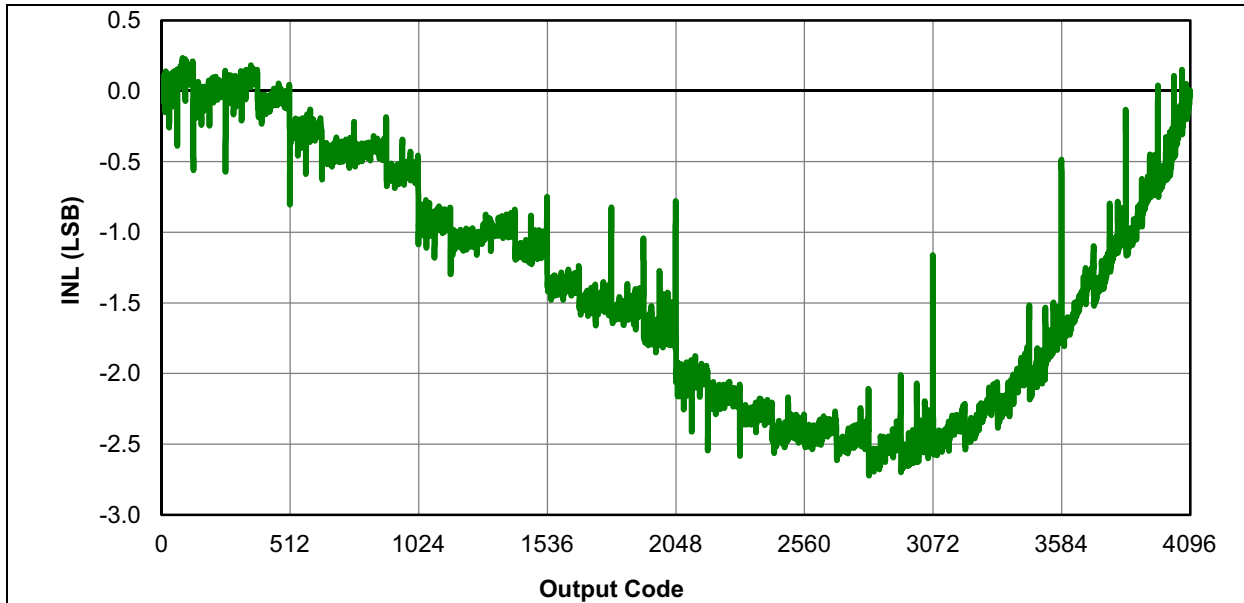
FIGURE 1: ADC 12-BIT MODE, SINGLE-ENDED INL, $V_{DD} = 3.0V$, $T_{AD} = 4 \mu s$, $25^{\circ}C$, TYPICAL MEASURED VALUES

The ADC linearity is ± 4 LSB for the 12-bit mode. Below are typical INL graphs in 12-bit mode (See [Figure 1](#) and [Figure 2](#)).

None.

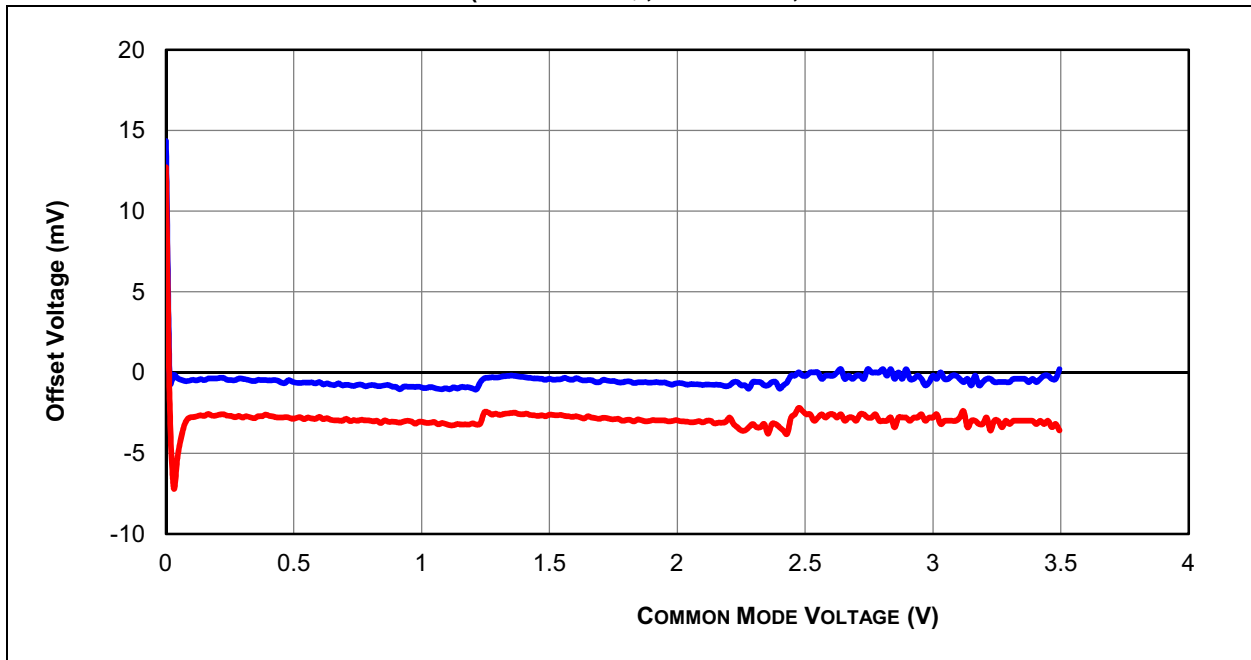
FIGURE 3: OP AMP TYPICAL OFFSET VOLTAGE AT 25°C, HIGH GBWP MODE (OPAxSP = 1), VDD = 3.6V, 0V ≤ CMV ≤ 5.5V

The op amp offset at Common mode input voltages below 200 mV increases with respect to temperature. Below are typical graphs showing the increase in offset (See [Figure 3](#), [Figure 4](#) and [Figure 5](#)).

None.

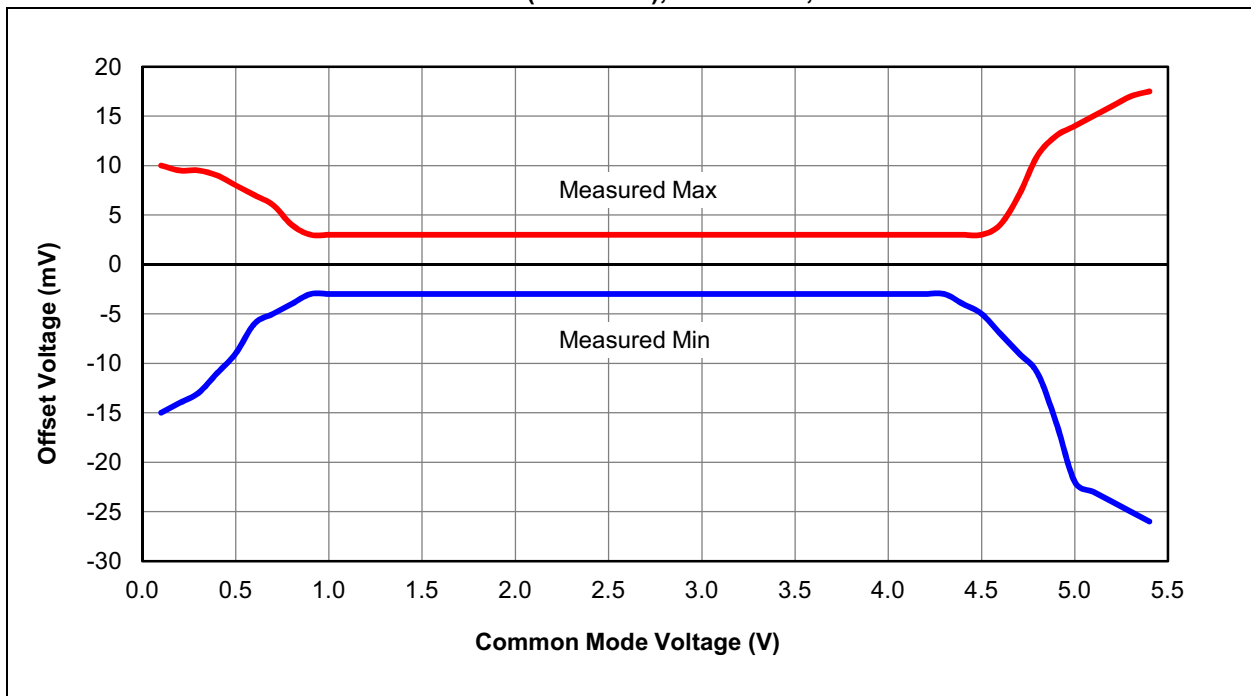
FIGURE 6: COMPARATOR INPUT OFFSET, TYPICAL MEASURED VALUES, NORMAL SPEED MODE (CxSP = 1), $V_{DD} = 5.5V$, PIC16F1782/1783 ONLY

CMRR performance for the range of $V_{SS} + 1V$ to $V_{DD} - 1V$ is better than specified in the data sheet.
