## PIC24FJ256GB110 Family Silicon Errata and Data Sheet Clarification

The PIC24FJ256GB110 family devices that you have received conform functionally to the current Device Data Sheet (DS39897C), except for the anomalies described in this document.

**Note:** This document summarizes all silicon errata issues from all revisions of silicon, previous as well as current. Only the issues indicated in the last column of [Table 2](#) apply to the current silicon revision (**A6**).

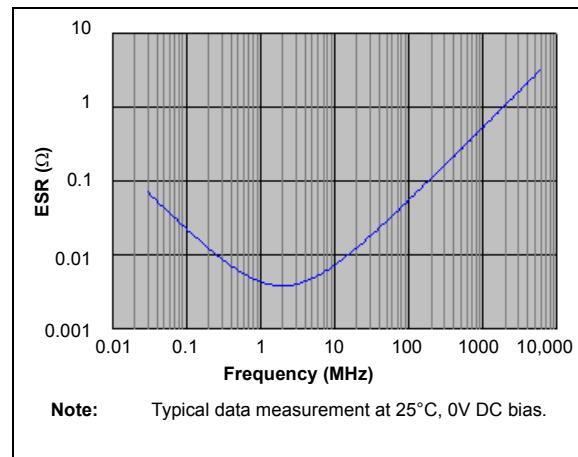
**FIGURE 2-3 FREQUENCY vs. ESR PERFORMANCE FOR SUGGESTED VCAP**

Designers may use [Figure 2-3](#) to evaluate ESR equivalence of candidate devices.

The placement of this capacitor should be close to VCAP/VDDCORE. It is recommended that the trace length not exceed 0.25 inch (6 mm). Refer to **Section 29.0 “Electrical Characteristics”** for additional information.
